**MTR Announces  
Launch of East Rail Line New Signalling System and 9-car Trains on 6 February and  
a Series of Measures to Enhance Shatin to Central Link Project Control**

**Investigation Panel Report  
on Route Recall Issue**

**Date: 8 December 2020**

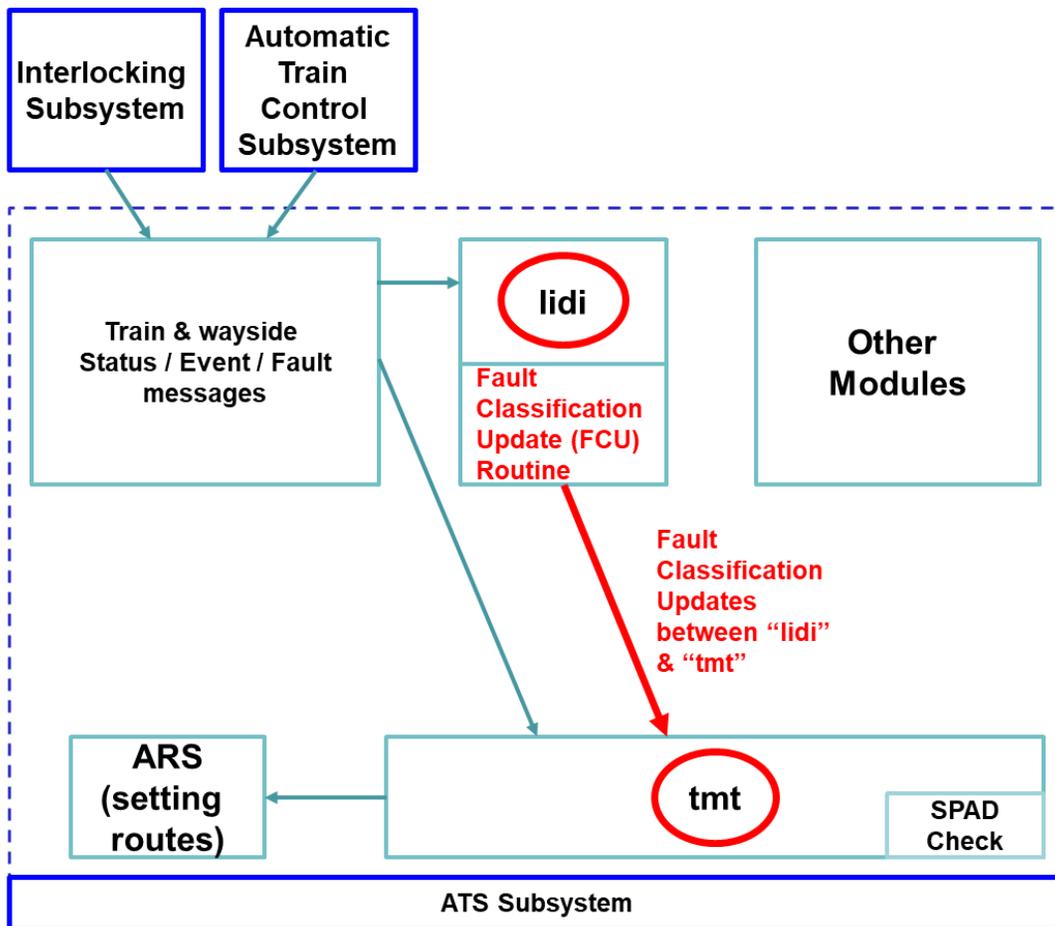
## Annex 2: TMT Data Processing between ATS modules “lidi” and “TMT”

The new TMT Data processing for “fault classification updates” messages made between the ATS module “lidi” and “TMT” as shown below, is a new and project specific feature tailor-made by the Contractor to fulfill the MTRCL’s requirement.

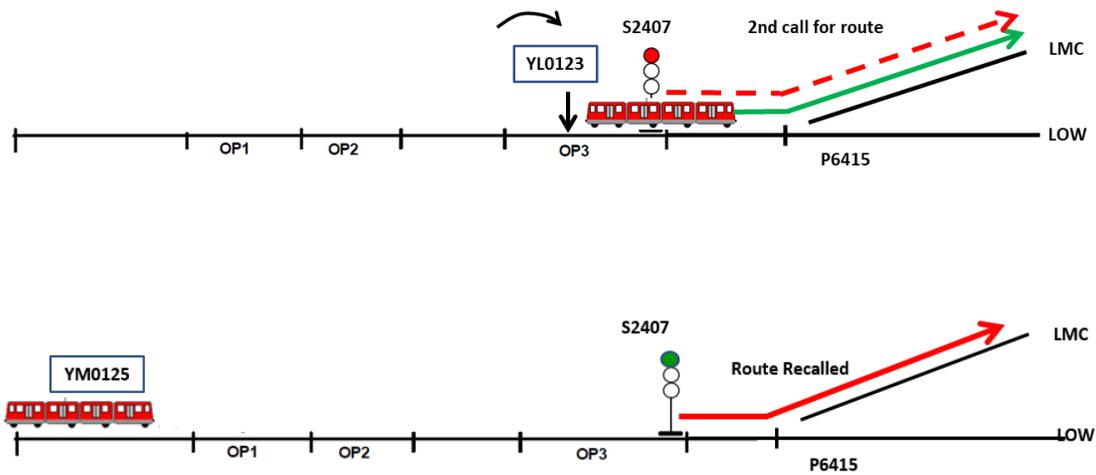
### 4. Consequence

Since the TD is located behind the train, even after the train has passed the signal and turned the signal to stop (Red) aspect, the ARS re-calls the route again when the delayed TD steps on OP3, as illustrated below. Such would lead to recalling of the same route as that of the

preceding train (YL0123), for this example, with destination of Lok Ma Chau (LMC) for the next train, and hence the following train (YM0125) may pick up the recalled route and go to its unintended destination. As illustrated in diagram below, the following train (YM0125) with original destination at Lo Wu (LOW) might be unintentionally routed to LMC.

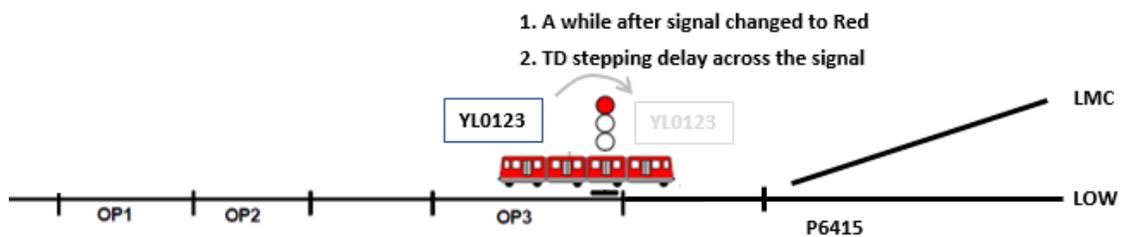
Another side effect is, subject to the extent of the delay “TD stepping”, false SPAD alarm may be resulted in TMT processing when the delayed TD steps across a red signal:

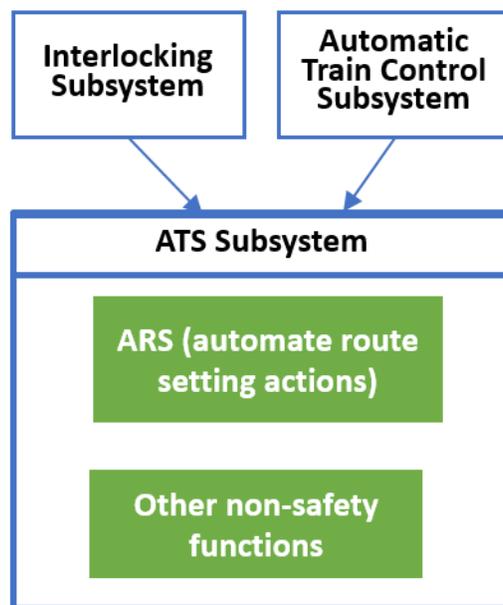
## 5. Safety functions remain intact

Route Recall Issue is not a safety related issue because the ARS is a non-safety related function provided by the ATS subsystem. The safety checks provided by the Interlocking subsystem and Automatic Train Control subsystem (including Automatic Train Protection i.e. ATP) as below, for route setting and train separation remain intact, i.e. all safety functions use the physical train locations and not the Train Descriptors to maintain a safe separation between trains. The ATP always monitors the physical position of the train to ensure that adequate safety distance is maintained between trains; and if not so maintained, the ATP will apply emergency braking.
