Shatin to Central Link – Contract 1109

**Incident Report on the Construction of the
Internal and Parapet Walls at TKW Station**

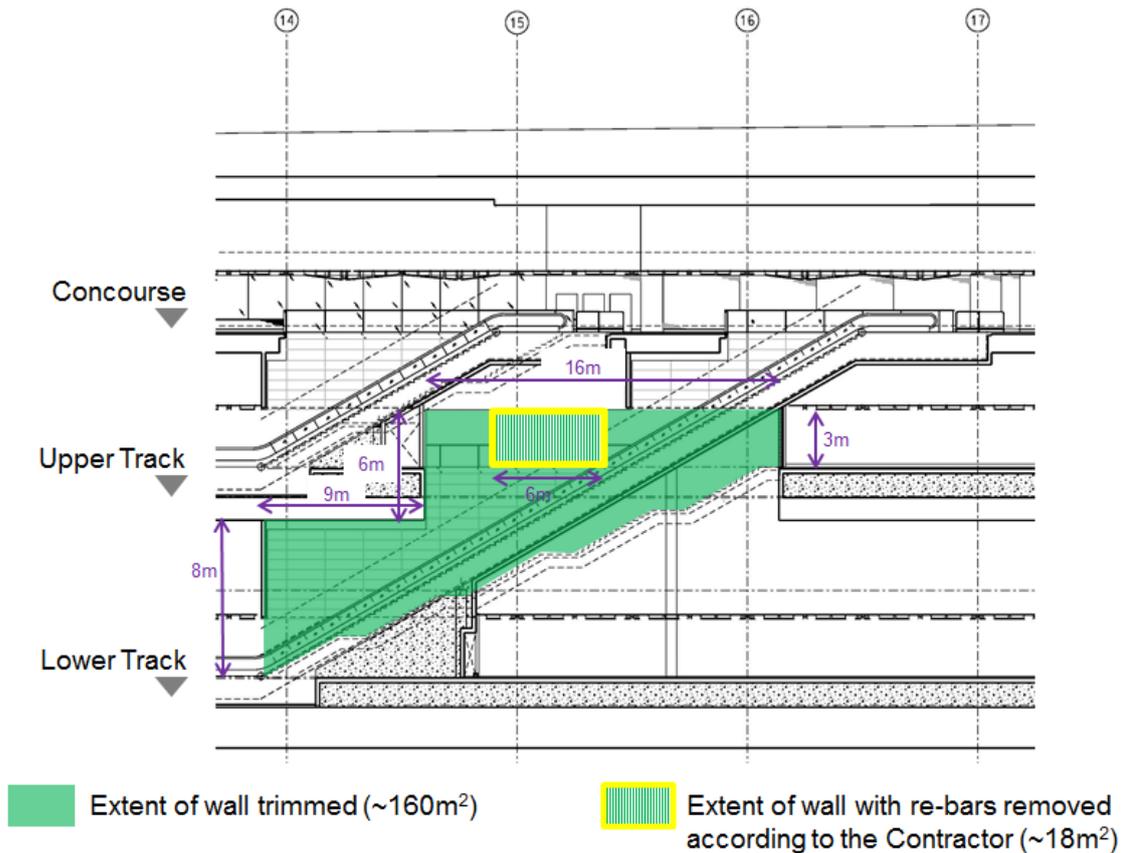
4.4 Extent of defect at the Internal Wall adjacent to ST-03

Based on the advice from the Contractor, the extent of the concrete trimming and repair work carried out at the Internal Wall adjacent to Staircase ST-03 was above the staircase level measuring approximately 160m². The thickness of the Internal Wall was trimmed from 200mm to an average of 175mm. The area with reinforcement bars removed from one face of the Internal Wall is advised by the Contractor as approximately 18m². The extent of defect at the Internal Wall adjacent to ST-03 is shown in **Figure 3** below.

Option 1 involves thickening of the Internal Wall from the Back of House face of the wall. A layer of vertical reinforcement bars and horizontal reinforcement bars will be fixed in front of the Back of House face of the defective section of the Internal Wall. The Back of House face of the defective wall will be roughened and installed with shear connectors to ensure a proper load transfer from the affected portion of the wall to the thickened section of the wall. Concrete will be poured to form the thickened wall. This option will not be possible where the existing wall is backed with infill concrete.

Option 2 involves removing the architectural finishes and opening up the concrete from the Front of House face of the defective section of the wall. The concrete will be over-broken to provide enough physical room to install the missing reinforcement bars. Temporary supports to maintain stability will be installed if required during this stage. In order to achieve the required concrete cover, the horizontal bars will be inserted behind the vertical bars. The opened up area will be repaired by the approved method statement referred to in Section 5.3 above.

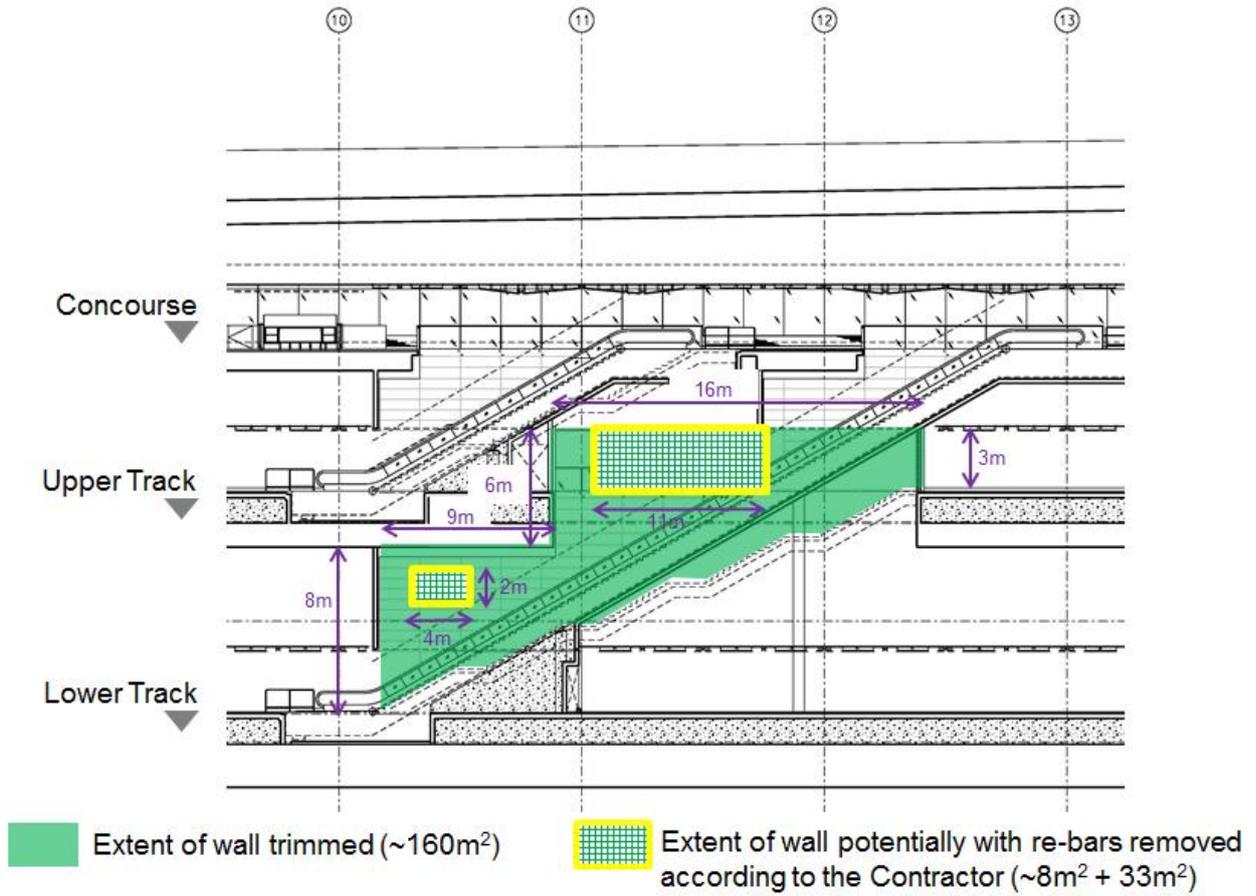
4.5 Extent of defect at Internal Wall adjacent to ST-04

Based on the advice from the Contractor, the extent of the concrete trimming and repair work carried out at the Internal Wall adjacent to Staircase ST-04 was similar to that adjacent to ST-03. The area was also approximately 160m², above the staircase level. The thickness of the wall was trimmed from 200mm to an average of 180mm. As advised by the Contractor, reinforcement bars were removed from one face of the Internal Wall at two locations measuring approximately 8m² and 33m². The extent of defect at the Internal Wall adjacent to ST-04 is shown in **Figure 4** below.

On 15 June 2018, the Contractor submitted a report to MTRCL which stated that 2 similar situations are suspected to have occurred at two other localized areas (estimated by the Contractor to be approximately 8m² and 33m²) of the same Internal Wall adjacent to Staircase ST-04.
