**MTR Announces  
Launch of East Rail Line New Signalling System and 9-car Trains on 6 February and  
a Series of Measures to Enhance Shatin to Central Link Project Control**

**Investigation Panel Report  
on Route Recall Issue**

**Date: 8 December 2020**

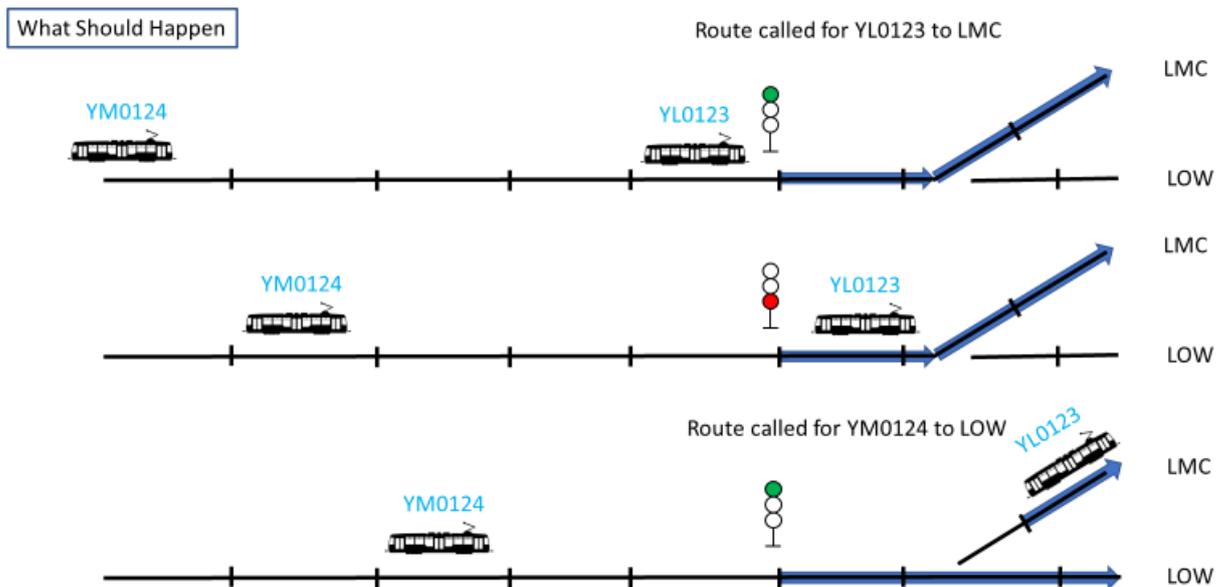
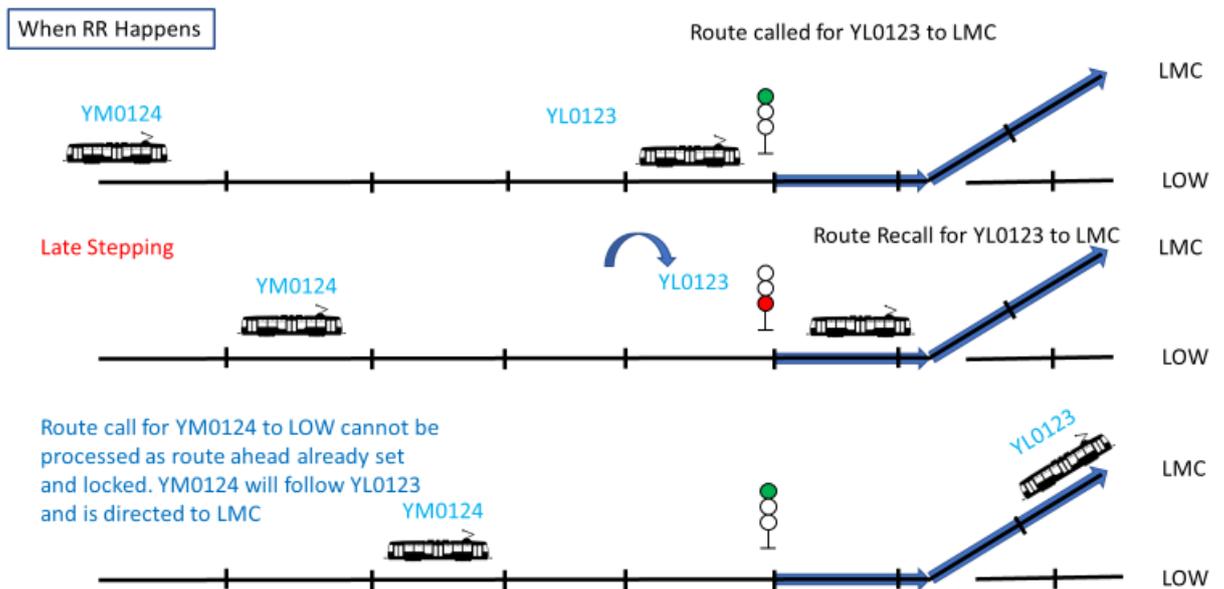
3.1 *Initial discovery:* As part of the process to satisfy itself of the safety and soundness of the new signalling system and MFO (hereafter referred to as “the project”), MTRCL conducted extensive testing during NTH. The RR issue was first noted in an NTH test on 11 May. When a train that has already been given a route by the Automatic Route Setting (ARS) system physically moves past a signal, the route should be released. However, if the virtual representation of the train lags slightly behind its actual position (this phenomenon is termed “late stepping”) RR could occur. The virtual representation of trains is tracked and reported by a sub-function, Train Monitoring and Tracking (TMT) of the Automatic Train Supervision (ATS) system. When a ‘late stepping’ issue happens, the ARS sets or “re-calls” the identical route, which can be picked up by the following train.

3.2 A RR issue can lead to a “deadlock” situation when a number of trains cannot continue along their path, because they are blocked by another train. At bifurcations and at stations with multiple platforms, an RR issue could potentially lead to a train taking the wrong route. There are no safety implications as the signalling safety sub-systems would maintain the safe separation of trains and prevent collisions even if a train took the wrong route. However, a RR issue may result in service disruption or passenger inconvenience through a delay of service or, train movement along an unintended route, even though safety is protected throughout the whole movement.

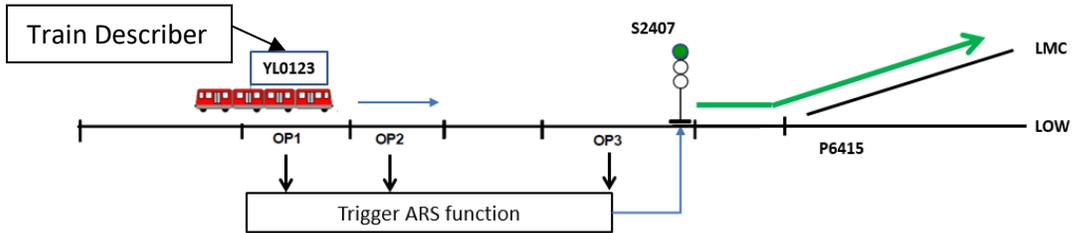
Train planned to Lok Ma Chau

Thereafter, the signal aspect would be turned to “Proceed” after route setting with conditions checked and completed by interlocking.

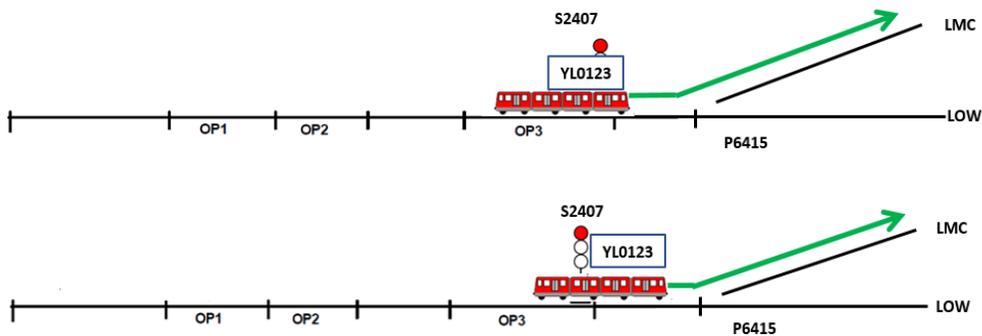
The TD would step forward as the physical train moves forward. As the train passes the signal, the signal aspect would be turned to Red and TD steps across the signal. The route set will be released as train passed the route.

As the following train YM0125 approaches with Red signal aspect and no route ahead, automatic route setting for it will occur when its TD steps on OP1, leading to its own destination to LOW as defined by TD.
