Shatin to Central Link – Contract 1109

**Incident Report on the Construction of the
Internal and Parapet Walls at TKW Station**

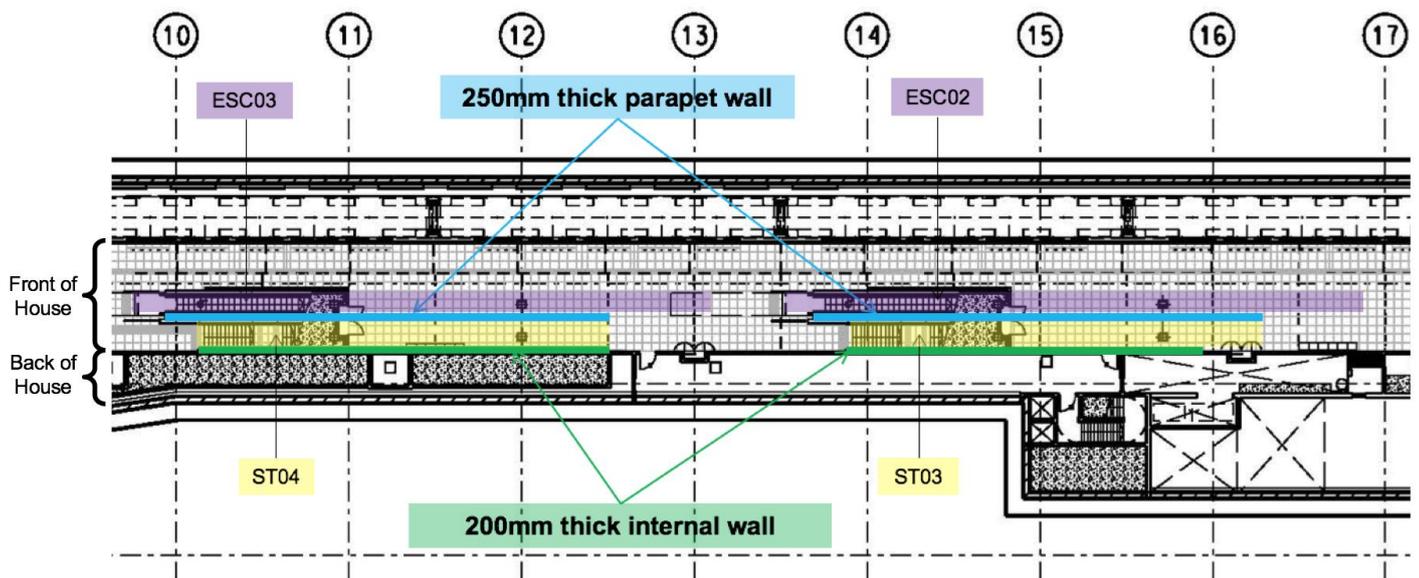
Figure 2 – Layout plan of the Internal Wall and Parapet Wall (lower platform level)

The Internal Wall adjacent to Staircase ST-03 and ST-04 is shown in **Figure 2** below.

The Parapet Wall adjacent to Staircase ST-03 and ST-04 is also shown in **Figure 2** above.
